STM32F10xx4 and STM32F10xx6 Errata sheet

STM32F101x4/6, STM32F102x4/6 and STM32F103x4/6
low-density device limitations

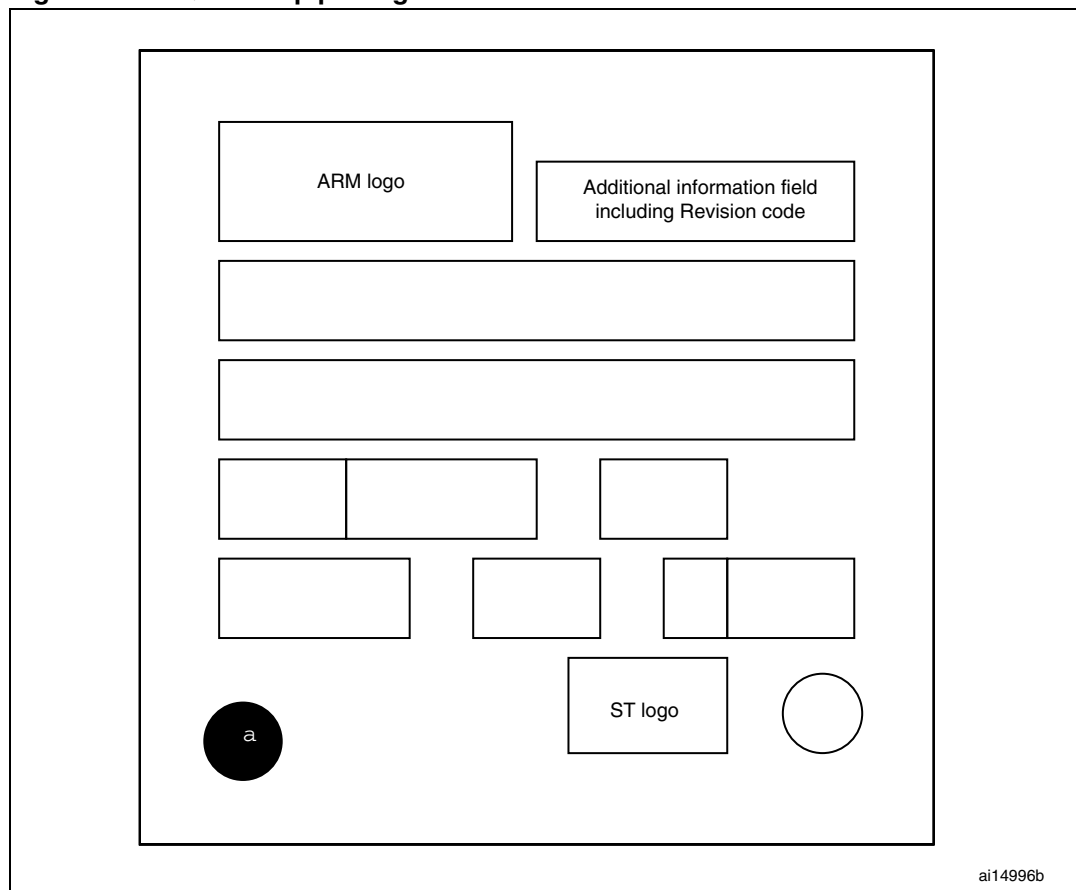
Figure 1. LQFP64 top package view

Figure 1, Figure 2 and Figure 3 show the marking compositions for the LQFP64, LQFP48 and VFQFPN36 packages, respectively. Only the Additional field containing the Revision code is shown.

- by the Revision code marked below the Sales Type on the device package
- by the last three digits of the Internal Sales Type printed on the box label
